PHOTOGRAPHIC SURVEY OF THE LDEF MISSION

National Aeronautics and
Space Administration

NASA Special Publication 531
1996

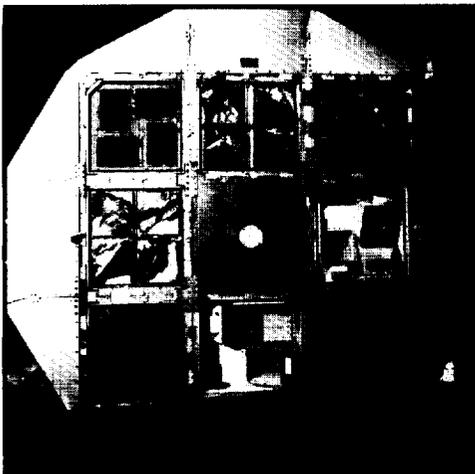
Figure 24
Photo No.: S32-82-060
Dup. Neg. No.: L90-10466
LISAR No.: EL-1994-00101
Photo Credit: JSC
Photo Date: 1/12/90
Location: In Flight
Subject: LDEF With Space End in Foreground
During Berthing in Cargo Bay

Figure 24 (In Flight). This view shows the space end of the LDEF during berthing in the cargo bay of the orbiter with the RMS. Note the damage to the thermal covers of the experiment M0001 and the prominent brown discolorations on other experiment hardware.

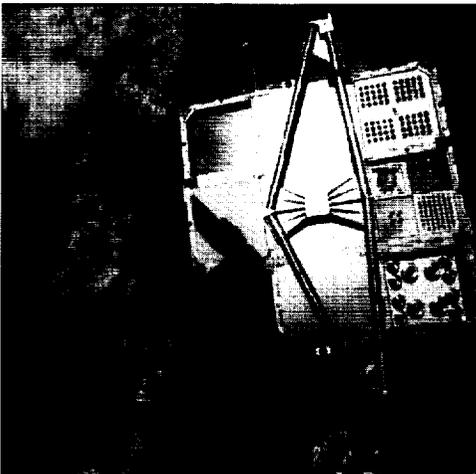
Figure 26
Photo No.: S32-85-081
Dup. Neg. No.: L90-10488
LISAR No.: EL-1994-00126
Photo Credit: JSC
Photo Date: 1/12/90
Location: In Flight
Subject: LDEF on RMS With Earth End in
Foreground

Figure 26 (In Flight). This view shows the Earth-facing end of the LDEF on the RMS with the cloud cover of the Earth as background. Note the brown discolorations on several of the painted surfaces of the experiments. The orbiter, in the lower left corner of the photograph, is in the shadow of the LDEF. There is a shadow of the RMS across the left portion of the photograph.

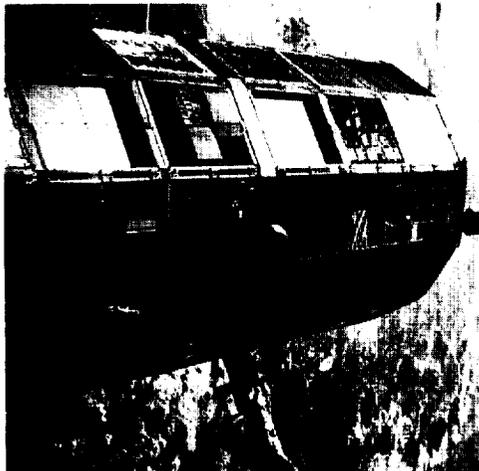
Figure 28
Photo No.: S32-75-008
Dup. Neg. No.: L90-10348
LISAR No.: EL-1994-00078
Photo Credit: JSC
Photo Date: 1/12/90
Location: In Flight
Subject: Close-up of LDEF on RMS Showing
Bays A Through E in Rows 2 Through 5

Figure 28 (In Flight). This close-up side view shows bays A through E in rows 2 through 5 with the LDEF on the RMS. Direct sun and reflections caused some experiment details in row 4 to be washed out, while low light levels caused a lack of detail in other rows. Wrinkles in the thermal screens in tray B3 are prominent. The thermal covers of trays of experiment AO178 in row 5 show reflections of the Earth and the sky.

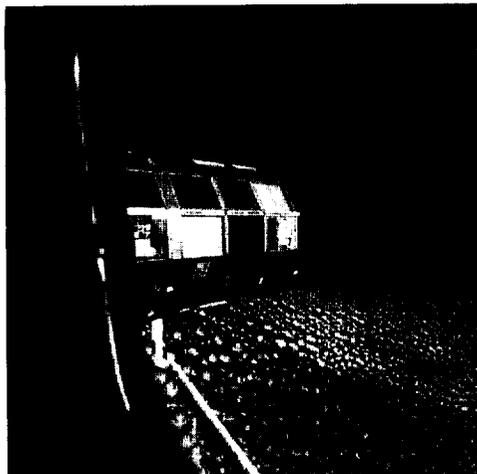
Figure 32
Photo No.: S32-85-025
Dup. Neg. No.: L90-10471
LISAR No.: EL-1994-00105
Photo Credit: JSC
Photo Date: 1/12/90
Location: In Flight
Subject: LDEF on RMS Showing Bays A
Through D in Rows 2 Through 6

Figure 32 (In Flight). A side view shows bays A through D in rows 2 through 6 with the LDEF on the RMS and the Earth in the background. The frame of the aft flight deck window of the orbiter is visible along the left side of the photograph. Reflections of the sky are visible in the thermal covers of experiment AO178.

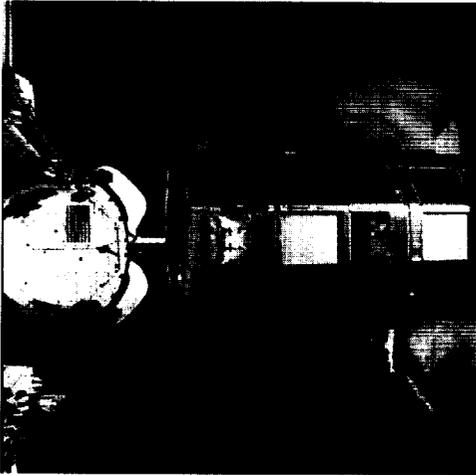
Figure 33
Photo No.: S32-85-030
Dup. Neg. No.: L90-10473
LISAR No.: EL-1994-00106
Photo Credit: JSC
Photo Date: 1/12/90
Location: In Flight
Subject: LDEF on RMS Showing Bays C Through F
in Rows 2 Through 6

Figure 33 (In Flight). This figure is a side view of bays C through F in rows 2 through 6 with the LDEF on the RMS. This view of the LDEF shows the Space Shuttle passing over the west coast of southern Africa. Note the sand dunes below the RMS and also their reflection in the thermal covers of experiment AO178 in trays F2 and E2. The thermal cover attachment pads of trays C5, D5, and F4 are also visible.

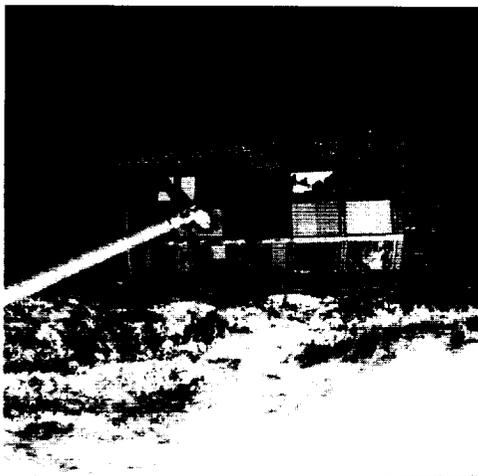
Figure 34
Photo No.: S32-85-050
Dup. Neg. No.: L90-10479
LISAR No.: EL-1994-00108
Photo Credit: JSC
Photo Date: 1/12/90
Location: In Flight
Subject: Wide-Angle View of LDEF on RMS
Showing Bays A Through F in Rows 11, 12,
and 1 Through 3

Figure 34 (In Flight). This wide-angle view shows bays A through F in rows 11, 12, and 1 through 3 with the LDEF on the RMS against a background of the Earth and clouds. The aft flight deck window frame obscures the upper part of the photograph. Note the clean appearance of the white paint in row 12 compared with similar paint on experiment hardware in rows 2 and 3. The original bright yellow paint on the trunnion scuff plates on row 3 has darkened significantly.

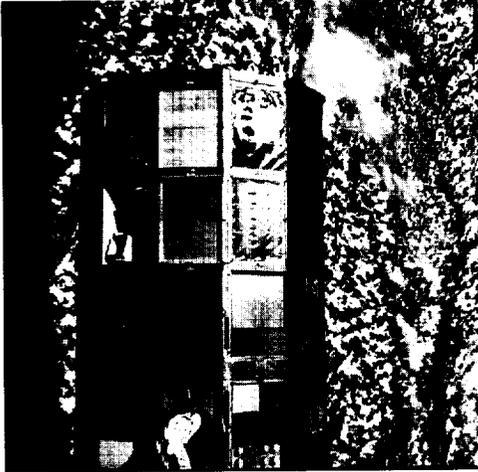
Figure 35
Photo No.: S32-85-054
Dup. Neg. No.: L90-10480
LISAR No.: EL-1994-00109
Photo Credit: JSC
Photo Date: 1/12/90
Location: In Flight
Subject: LDEF on RMS Showing Bays C Through F
in Rows 11, 12, and 1 Through 3

Figure 35 (In Flight). This side view shows bays C through F in rows 11, 12, and 1 through 3 with the LDEF on the RMS. The aft flight deck window frame forms a shadow on the left edge of the photograph. The Earth with a cloud cover provides the background. Note the clean appearance of the white paint on the thermal covers in row 12 when compared with similar paint on the hardware in rows 2 and 3. The white paint dots on the experiment tray clamp blocks on row 12 appear clean; however, the dots darken progressively as row 3 is approached. The original bright yellow paint on the trunnion scuff plates on row 3 has darkened significantly.

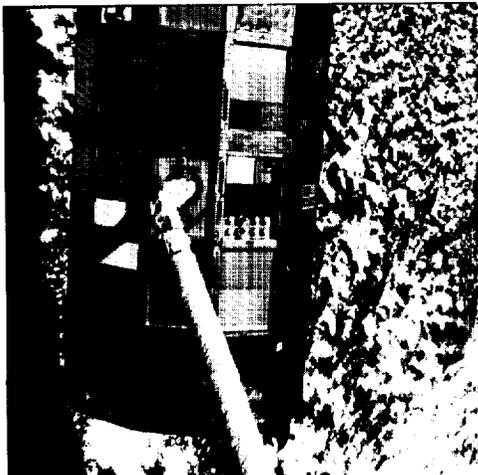
Figure 36
Photo No. S32-85-056
Dup. Neg. No.: L90-10481
LISAR No.: EL-1994-00110
Photo Credit: JSC
Photo Date: 1/12/90
Location: In Flight
Subject: LDEF on RMS Showing Bays A Through D
in Rows 11, 12, and 1 Through 3

Figure 36 (In Flight). This side view shows bays A through D in rows 11, 12, and 1 through 3 with the LDEF on the RMS. The aft flight deck window frame forms a shadow on the left edge of the photograph and the Earth with a cloud cover provides the background. Note the clean appearance of the white paint on the thermal covers in row 12 when compared with similar paint on experiment hardware in rows 2 and 3. The original bright yellow paint on the trunnion scuff plates on row 3 has darkened significantly.

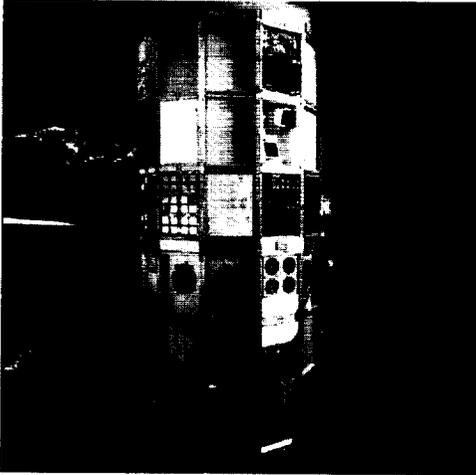
Figure 37 (In Flight). This figure shows a side view of bays A through F in rows 9 through 12 and 1 with the LDEF on the RMS. The orbiter vertical stabilizer protrudes from the left edge of the photograph. The right side of the photograph is obscured by the frame of the aft flight deck window. The peculiar light pattern in the trays in row 11 and the variations along the row indicate that the cargo bay lights were on.

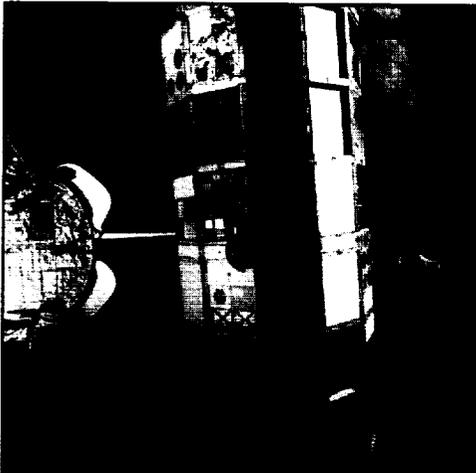
Figure 38 (In Flight). This view shows bays A through F in rows 8 through 12 with the LDEF on the RMS. The cargo bay of the orbiter is on the left side of the photograph. Either sunlight reflected from the cargo bay or cargo bay lights illuminate rows 8 and 9.

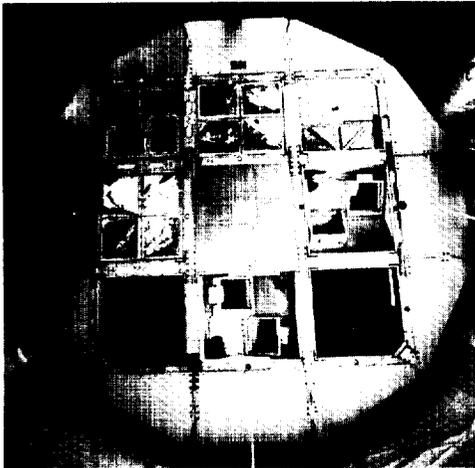
Figure 43
Photo No.: S32(S)-294
Dup. Neg. No.: L92-21201
LISAR No.: EL-1994-00100
Photo Credit: JSC
Photo Date: 1/22/90
Location: Dryden
Subject: Space End of LDEF Viewed From Cargo Bay Hatch

Figure 43 (Postflight). This view of the space end of the LDEF was taken from the cargo bay access hatch after the *Columbia* landed at Edwards Air Force Base, California. The cargo bay liner is visible in the bottom of the photograph. The radiators, which are located on the inside of the orbiter payload bay doors, are visible in the top. The three yellow balls on the aluminum support rods (whiskers) that are fixed in the cargo bay were used for berthing the LDEF during retrieval operations. A brown discoloration appears to be spread over the surface of the space end of the LDEF. This discoloration appears to be lighter on the anodized aluminum thermal panel surfaces and darker on the experiment surfaces that were coated with the Chemglaze A276 white thermal control paint. The discoloration on the uncoated aluminum hardware (such as the end frame splice plates) is also darker. The amber and red reflectors seem to have little apparent degradation.

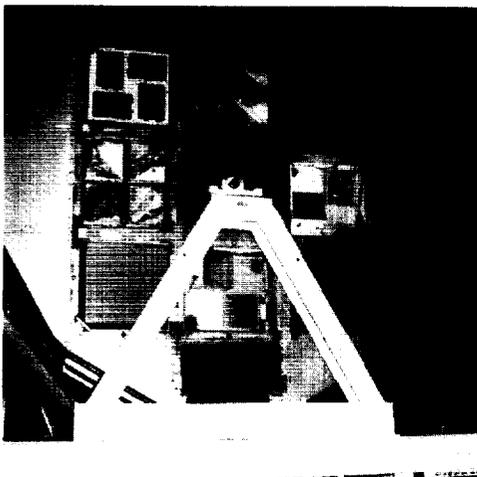
Figure 46
Photo No.: L90-1778
LISAR No.: EL-1994-00477
Photo Credit: LaRC
Location: KSC SAEF II
Subject: Postflight View of Space End of LDEF

Figure 46 (Postflight). This postflight view is of the space end of the LDEF in the SAEF II. The discoloration in the areas of trays H6 and H9 (containing experiment AO038) and the damage to the thermal covers of experiment M0001 in trays H3 and H12 are evident. Note that the thermal panel below tray H6 has been removed.

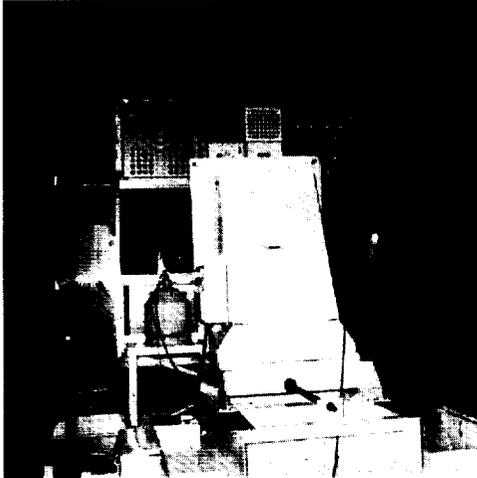
Figure 47
Photo No.: KSC-390C-833.05
Dup. Neg. No.: L90-13364
LISAR No.: EL-1994-00715
Photo Credit: KSC
Photo Date: 2/7/90
Location: KSC SAEF II
Subject: Postflight View of Earth End of LDEF

Figure 47 (Postflight). This postflight view is of the Earth end of the LDEF in the SAEF II. Some discoloration of the thermal panels on the left side of the photograph is visible. This area was affected by the end support beam in flight, which was removed when this photograph was made. The canister on the stand adjacent to tray G8 was part of the instrumentation setup for radiation measurements.

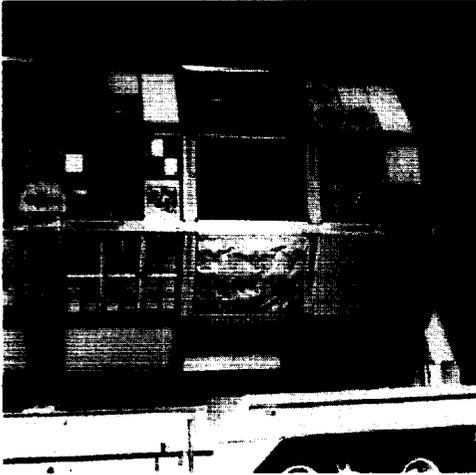
Figure 57
Photo No.: KSC-390C-1029.02
Dup. Neg. No.: L90-13388
LISAR No.: EL-1994-00288
Photo Credit: KSC
Photo Date: 2/9/90
Location: KSC SAEF II
Subject: Postflight View of Bays D Through F in
Rows 8 Through 11 Prior to Removal of
Experiments

Figure 57 (Postflight). This postflight view is of the LDEF in the SAEF II prior to removal of the experiment trays. Bays D through F in rows 8 through 11 are visible.

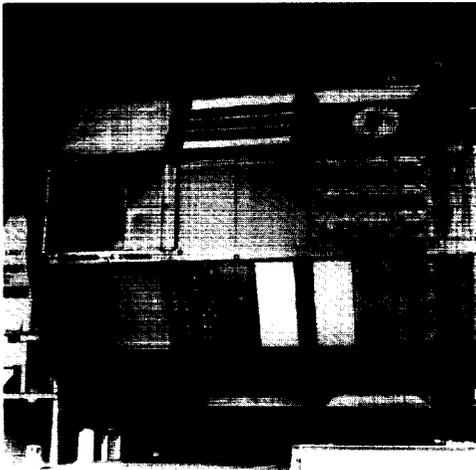
Figure 58
Photo No.: KSC-390C-1069.05
Dup. Neg. No.: L90-13485
LISAR No.: EL-1994-00150
Photo Credit: KSC
Photo Date: 2/8/90
Location: KSC SAEF II
Subject: Postflight View of Bays A Through C in
Rows 10 Through 12 and 1 Prior to Removal of
Experiments

Figure 58 (Postflight). This postflight view is of the LDEF in the SAEF II prior to removal of the experiment trays. Bays A through C in rows 10 through 12 and 1 are visible.

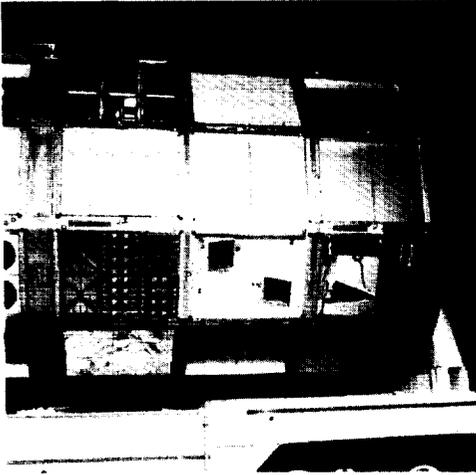
Figure 59
Photo No.: KSC-390C-1069.06
Dup. Neg. No.: L90-13486
LISAR No.: EL-1994-00063
Photo Credit: KSC
Photo Date: 2/8/90
Location: KSC SAEF II
Subject: Postflight View of Bays D Through F in
Rows 10 Through 12 and 1 Prior to Removal of
Experiments

Figure 59 (Postflight). This postflight view is of the LDEF in the SAEF II prior to removal of the experiment trays. Bays D through F in rows 10 through 12 and 1 are visible.

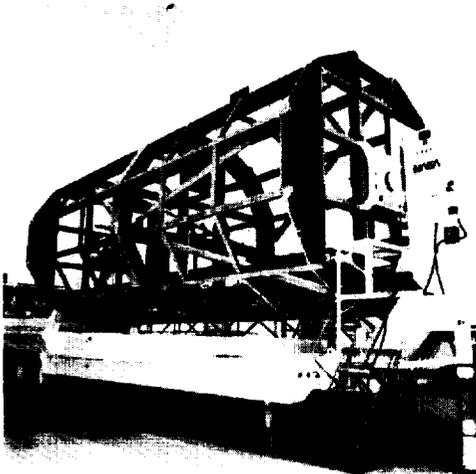
Figure 60
Photo No.: KSC-390C-2366.01
Dup. Neg. No.: L92-17916
LISAR No.: EL-1994-00698
Photo Credit: KSC
Photo Date: 3/28/90
Location: KSC SAEF II
Subject: Postflight View of Earth End of LDEF
With Trays Removed

Figure 60 (Postflight). This postflight view is of the LDEF in the SAEF II after all experiment trays except the grapple fixture trays were removed. This oblique view is of the Earth-facing end and a side.

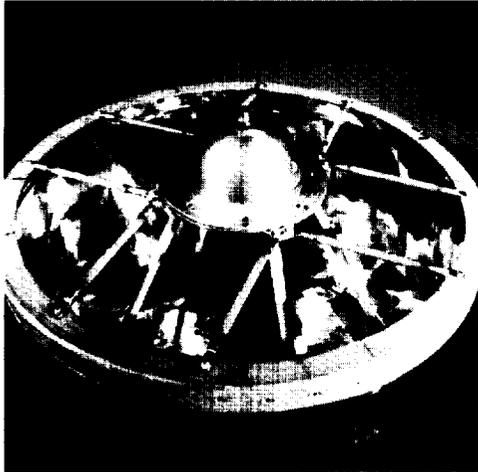
A viscous magnetic rate damper was selected to provide damping should significant motions occur at LDEF deployment. Such damping would ensure capture in a gravity gradient with one end toward earth. Dampers of this type had been successfully flown on other spacecraft. Comprehensive stability analyses of the LDEF were conducted to define damper performance requirements and are reported in references 7 and 8. The damper that was flown is shown in a postflight photograph in figure 63.

Figure 63 (Postflight). This photograph is of the magnetically anchored viscous damper after removal from the LDEF. The bolts that fastened the damper to the fiberglass support structure have been removed. The damper had a gold coating for thermal control in flight.

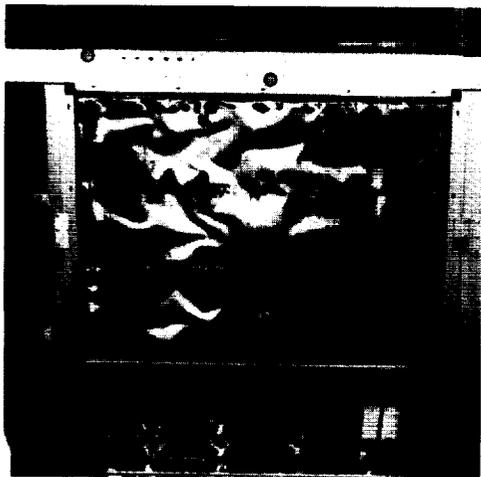
Figure 74
Photo No.: KSC-390C-1066.06
Dup. Neg.: L90-13475
LISAR No.: EL-1994-00387
Photo Credit: KSC
Photo Date: 2/8/90
Location: KSC SAEF II
Subject: Postflight Survey of Thermal Cover of
Tray A2

Figure 74 (Postflight). The thermal cover appears to be specular and undamaged. It is less taut than in the in-flight photograph. The uniformly located oval spots on the thermal cover are areas where Velcro pads attach the thermal cover to the support frame; these spots are more visible than in the prelaunch photograph. The scallop effect around the cover edges occurs between the attachment pads and shows the upper edge of the support frame. The ground strap appears to be in place with no visible damage, although it is darker.

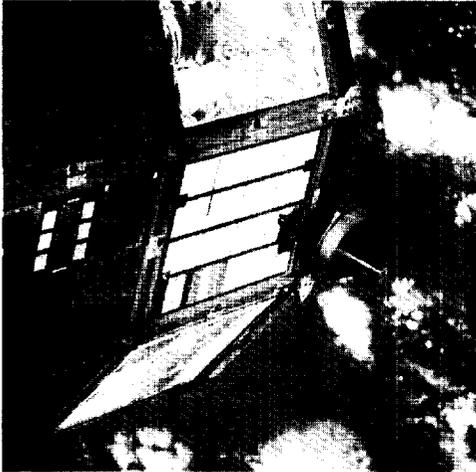
Figure 82 (In Flight). The canisters are shown in open positions in the center tray of bay A. They were expected to open about 2 weeks after launch and close about 11 months into the mission. All exposed materials are secure and no damage is evident. Contamination stain coats the tray flanges and the aluminum canister hardware. The end support beam scuff plate in the photograph was a bright yellow prior to launch, but it is now a much darker mustard yellow after space exposure.

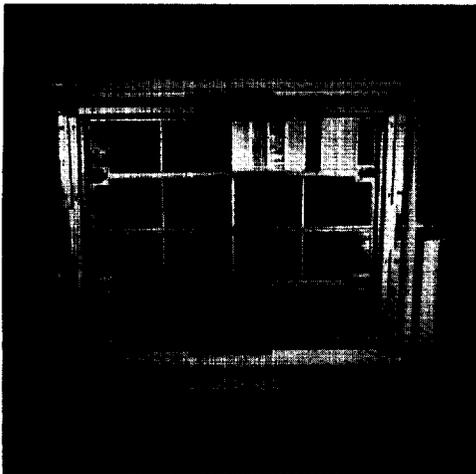
Figure 83 (Postflight). The experiment is shown in the postflight configuration before the canisters were closed with ground support equipment that bypassed the onboard electronic circuits. There is no visible damage. The reflection of a video camera on a tripod and light sources are visible in the surfaces of the gold foil.

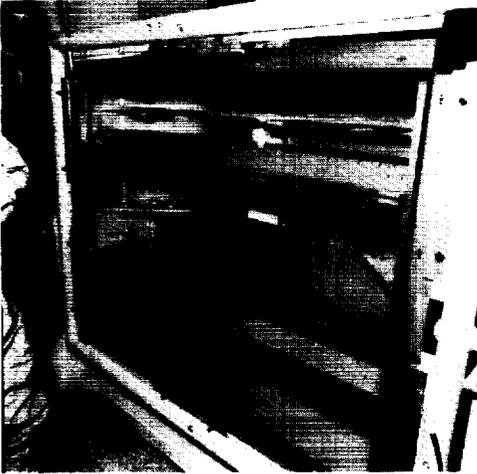
Figure 84 (Postflight). The experiment canisters are shown after being closed by ground support equipment. The experiment hardware has no damage.

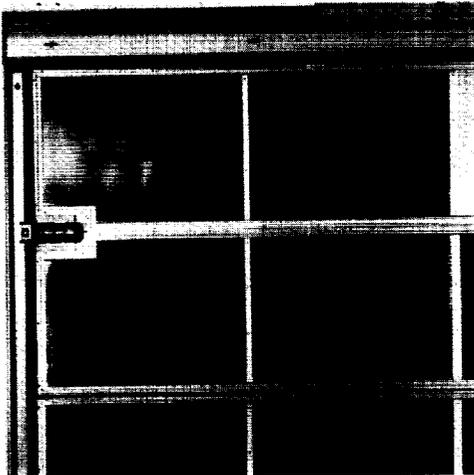
Figure 85 (Postflight). This photograph of the upper left one-fourth of the tray shows light and room reflections in the gold foil. The foil appears to be in preflight condition.

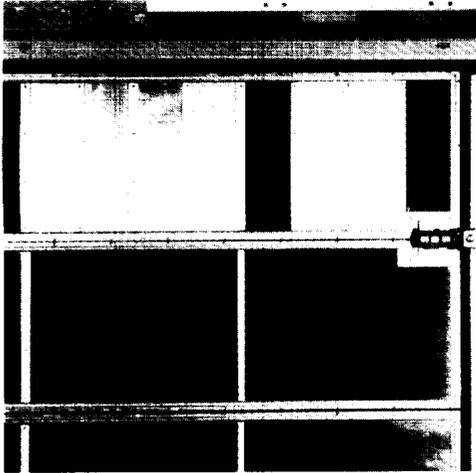
Figure 86 (Postflight). This photograph of the upper right one-fourth of the tray shows light and room reflections in the highly reflective gold foil. The foil appears to be in preflight condition. Photographic lights washed-out details of the test strips along the top of the tray.

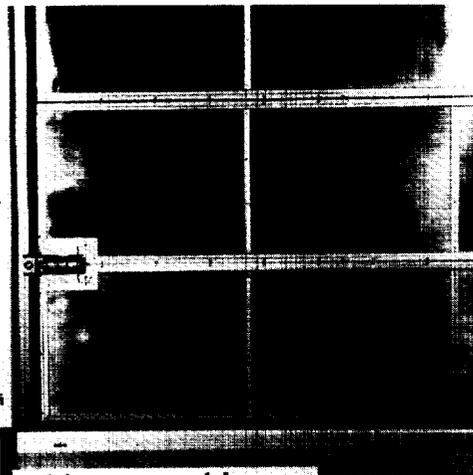
Figure 87 (Postflight). This photograph of the lower left one-fourth of the tray shows light and room reflections in the highly reflective gold foil. The foil appears to be in preflight condition.

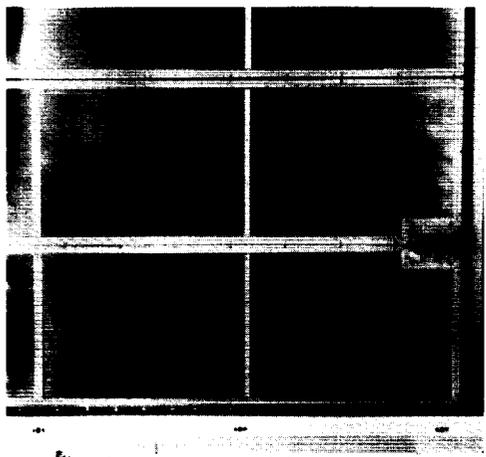
Figure 88 (Postflight). This photograph of the lower right one-fourth of the tray shows light and room reflections in the highly reflective gold foil. The green is a reflection of the clean room garments that were worn by nearby personnel. The foil appears to be in preflight condition.

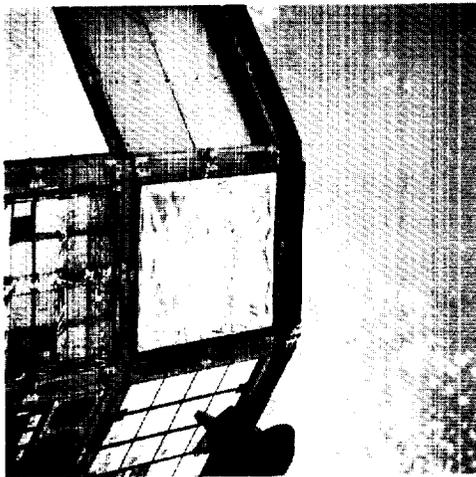
Figure 89 (In Flight). The thermal cover appears to be specular and undamaged, but it is more taut than in the prelaunch photograph. The wrinkled spots on the thermal cover are areas where Velcro pads are bonded to the back of the cover. The scalloped effect around the cover edges occurs between the attachment pads. The ground strap appears to be in place and to have no visible damage.

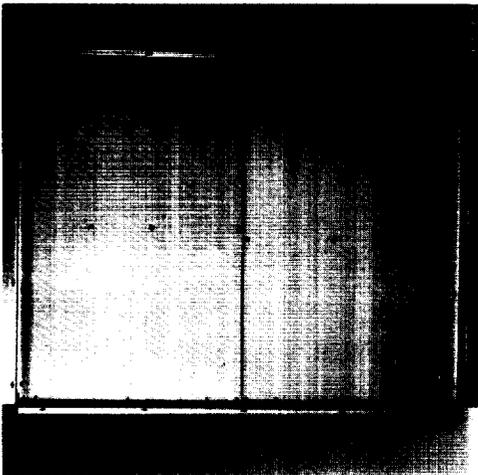
Figure 98 (Preflight). Because trays dedicated to experiment S0001 (except tray A6, which had the target for the keel camera) were not photographed prior to flight, a spare tray was photographed for descriptive purposes. Experiment S0001 consisted of two 3/16-in-thick chromic-anodized aluminum panels that were mounted in a 3-in-deep peripheral tray. The panel had two coatings: a thin layer of chromic anodization that faced the exterior and a Chemglaze-306 black paint that faced the interior. Both coatings contributed significantly to thermal control of the LDEF. The pink and greenish-gray tints and the vertical stripes on the two debris panels were by-products of the chromic anodization coating process. The anodization appears to make surface features or markings more visible.

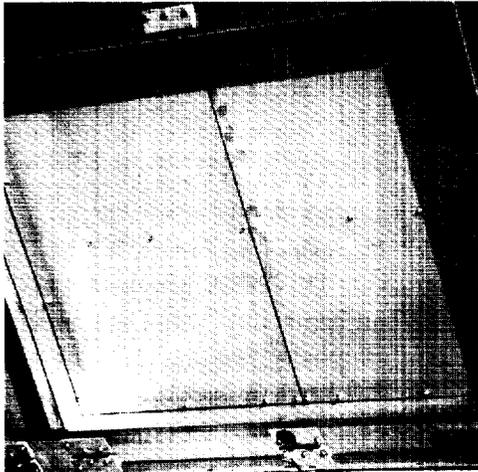
Figure 99 (In Flight). Fingerprints that were observed on the lower tray flange and the sidewall indicate the lack of proper preflight handling and cleaning. The greenish-gray and pink tints on the two debris panels are by-products of the chromic anodization coating process and are not attributed to contamination or exposure to the space environment.

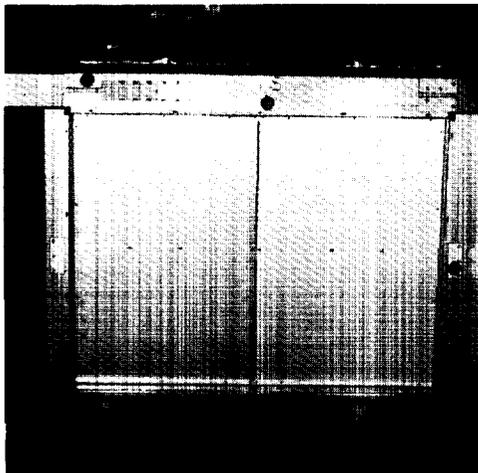
Figure 100 (Postflight). The greenish-gray and pink tints on the two debris panels are by-products of the chromic anodization coating process and are not attributed to contamination or exposure to the space environment. The fingerprints along the edges of the left panel that were observed in the in-flight photograph are still visible. Those visible previously along the top edges have been washed out by the lighting. The light band along the sides and across the bottom of the panels is caused by light reflecting from the tray sidewalls.

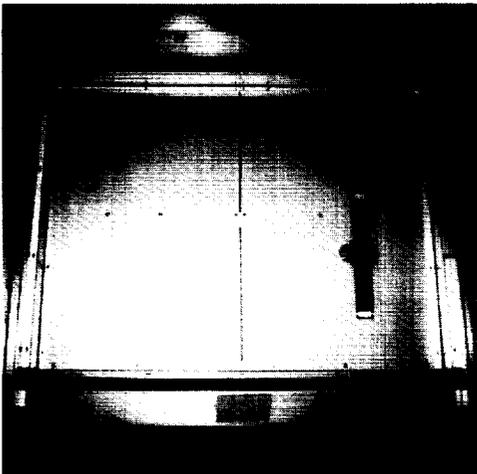
Figure 101 (Preflight). This tray is typical of the other 18 trays dedicated to experiment S0001 except for the target for the Shuttle keel camera and the reflector. The target and the reflector were visual aids for berthing the LDEF during retrieval. This photograph of tray A6 and the photograph of the spare flight tray shown in figure 98 can be used to judge the preflight appearance of the witness plates for experiment S0001. The greenish-gray and pink tints are by-products of the chromic anodization coating process. The line pattern is due to the rolling mill operation during manufacturing. The anodization makes such surface features more visible.

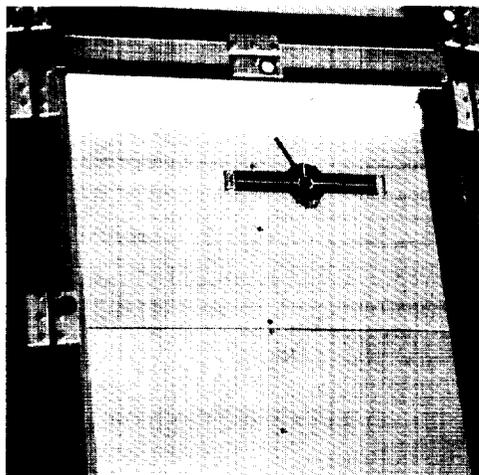
Figure 102 (In Flight). The pink and greenish-gray tints and the horizontal stripes on the two debris panels are by-products of the chromic anodization coating process and are not attributed to exposure to the space environment. The blue is due to lighting and is not a true change in surface color. The brown irregular discolorations along the center edges of the debris panels appear to be fingerprints from prelaunch handling. The black unit located on the top panel is a target for the keel camera that was used during the berthing of the LDEF. The stripes and the tip of the vertical rod of the target for the keel camera appear darker than in the prelaunch photograph. The light band across the top panel is reflected light from the tray sidewall and the dark band down the right side of the panels is a shadow from the tray sidewall.

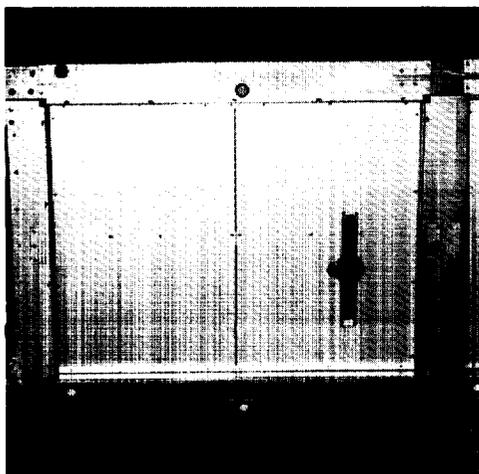
Figure 103 (Postflight). The pink and the greenish-gray tints on the two debris panels are by-products of the chromic anodization coating process and are not attributed to contamination or exposure to the space environment. The fingerprints along the center edges of the debris panels that were observed in the in-flight photograph are still visible. The vertical streaks on the debris panels appear to be the same as on the prelaunch photograph. The stripes and the tip of the vertical rod of the target for the keel camera appear darker than in the prelaunch photograph. The light band along the right side and across the bottom of the panels is caused by light reflecting from the tray sidewalls.

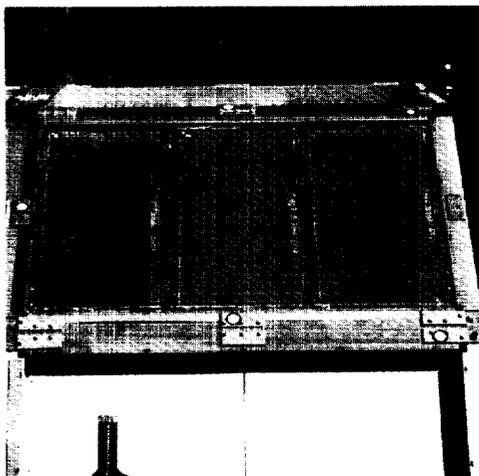
Figure 105 (In Flight). In this photograph, the dull gold-colored coating that was observed on the aluminum mounting strips in the preflight photograph has turned to a medium brown. The yellow numbers seem darker than in prelaunch conditions, but the white markings appear the same. There seems to be fine horizontal lines, cracks, and crazing on the surface of each panel. The PMR-15 panel on the left appears to have changed from brown (at prelaunch) to light gray. A geometric pattern, probably from the laminating process, is visible on the surface. Scratch marks and abrasions on the lower left edge of panel were on the preflight photographs. The F-178/T300 cocured panel in the center seems to have changed from dark brown to light gray. The F-178/T300 precured panel on the right appears to have changed from dark brown with a lighter brown area along the vertical center to a uniform light gray.

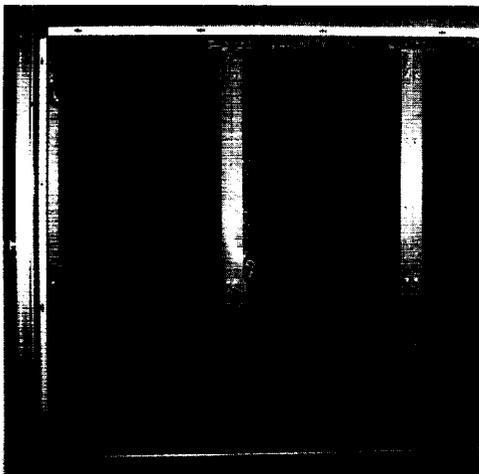
Figure 107
Photo No.: KSC-390C-2145.10
Dup. Neg. No.: L91-7659
LISAR No.: EL-1994-00503
Photo Credit: KSC
Photo Date: 3/21/90
Location: KSC SAEF II
Subject: Postflight Detail of Tray A7

Figure 107 (Postflight). This close-up photograph is of the two left panels (F-178/T300 precured and F-178/T300 cocured). The yellow numbers appear lighter than in the in-flight photograph. The fine horizontal lines, cracks, and crazing are still visible on the panel surface. The F-178/T300 precured panel seems to have changed to a brownish gray from the light gray visible in the in-flight photograph. The F-178/T300 cocured panel appears to have changed from the light gray in the in-flight photograph to a brownish gray.

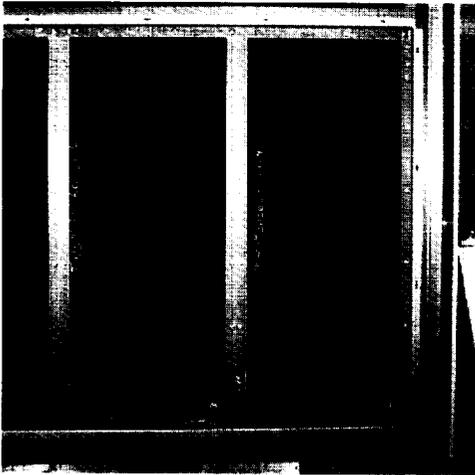
Figure 108
Photo No. KSC-390C-2145.11
Dup. Neg. No.: L91-7660
LISAR No.: EL-1994-00504
Photo Credit: KSC
Photo Date: 3/21/90
Location: KSC SAEF II
Subject: Postflight Detail of Tray A7

Figure 108 (Postflight). This close-up is of panels F-178/T300 cocured and PMR-15. The yellow identification numbers appear lighter. The fine horizontal lines, cracks, and crazing are still visible on the surface of each panel. The F-178/T300 cocured panel seems to have changed from the light gray in the in-flight photograph to a brownish gray. The geometric pattern visible on the PMR-15 panel in flight is not visible in this photograph. A gray haze or dust appears to cover the gray brown panel surface. Scratch marks and abrasions on the lower left edge of the panel were on preflight photographs.

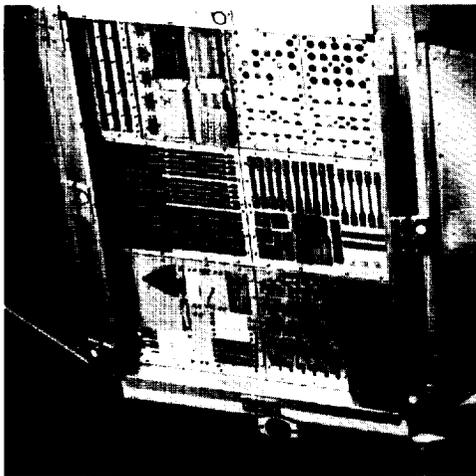
Figure 111
Photo No.: S32-76-027
Dup. Neg. No.: L90-10381
LISAR No.: EL-1994-00666
Photo Credit: JSC
Photo Date: 1/12/90
Location: In Flight
Subject: In-Flight Survey of Tray A8

Figure 111 (In Flight). Plate I, in the upper left, is shown with two of the four solar arrays missing and one solar cell appears to be attached at only one corner. Other components seem to be secure. The composites on Plate II in the left center appear to have no physical damage. On Plate III, in the lower left corner of the tray, the thin films without protective coatings on the lower left corner of the plate sustained significant damage or were destroyed. The metallized film apparently survived with minimum damage. On Plate IV, in the upper right corner, several of the coatings appear to have changed to a darker color and a light brown discoloration shows around the outer edges of the mounting plate and along the right edge of the coverplates. On Plate V, in the right center, all specimens, including the tape holding down the small specimen in the lower right corner, have darkened significantly during the extended time in space. On Plate VI, in the lower right corner, the solar cell components appear to have no physical damage. The colors of the test specimens, however, seem to have darkened.

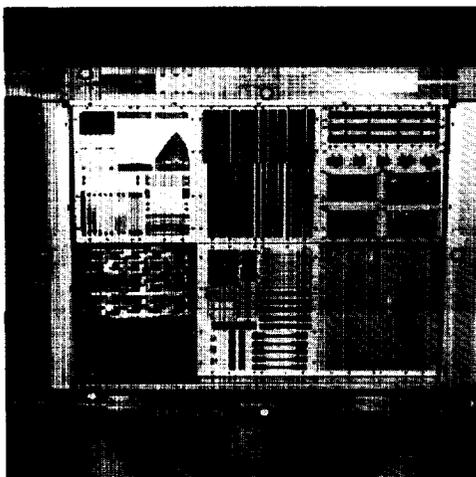
Figure 112
Photo No.: KSC-390C-1031.12
Dup. Neg. No.: L90-13422
LISAR No.: EL-1994-00147
Photo Credit: KSC
Photo Date: 2/9/90
Location: KSC SAEF II
Subject: Postflight Survey of Tray A8

Figure 112 (Postflight). Most test specimens in the experiment appear to have survived intact, while the remaining specimens suffered varying degrees of deterioration. On Plate I in the upper right, three of the four solar arrays are missing. One solar array apparently was the one that was flying free near the LDEF just prior to retrieval and another was found in the Space Shuttle bay after the LDEF removal. On Plate III, in the upper left, thin films without protective coatings sustained significant damage or were destroyed.

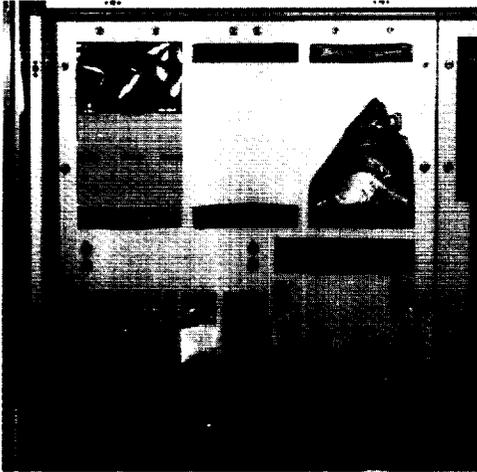
Figure 113
Photo No.: KSC-390C-1411.05
Dup. Neg.: L 91-7686
LISAR No.: EL-1994-00335
Photo Credit: KSC
Photo Date: 3/1/90
Location: KSC SAEF II
Subject: Postflight Detail of Upper Left of Tray A8

Figure 113 (Postflight). This close-up photograph of Plate III in the upper left one-sixth of the tray shows that the thin films without protective coatings sustained significant damage or were destroyed. The thin-film specimen, which is hanging by one end in the in-flight photograph, is missing. The metallized film apparently survived the mission with minimum damage.

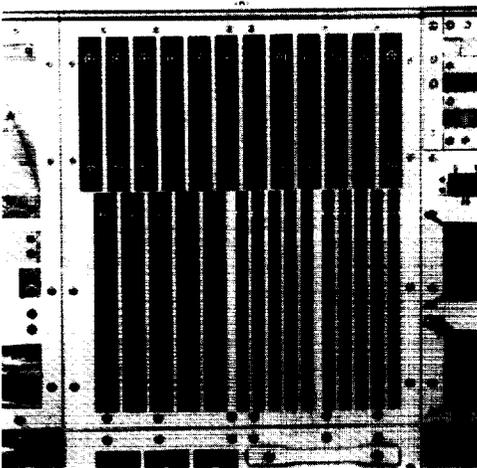
Figure 114
Photo No.: KSC-390C-1411.06
Dup. Neg. No.: L91-7687
LISAR No.: EL-1994-00336
Photo Credit: KSC
Photo Date: 3/1/90
Location: KSC SAEF II
Subject: Postflight Detail Survey of Upper Center of Tray A8

Figure 114 (Postflight). In this close-up photograph of Plate II in the upper center one-sixth of the tray, the composites appear to have no physical damage.

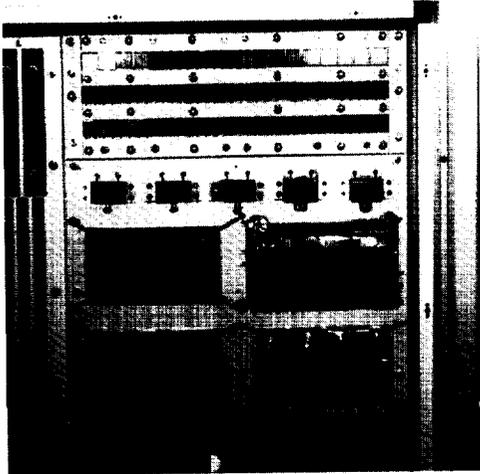
Figure 115
Photo No.: KSC-390C-1411.07
Dup. Neg. No.: L91-7688
LISAR No.: EL-1994-00337
Photo Credit: KSC
Photo Date: 3/1/90
Location: KSC SAEF II
Subject: Postflight Detail Survey of Upper Right of
Tray A8

Figure 115 (Postflight). On Plate I, in the upper right corner, three of the four solar arrays are missing. One apparently was the one flying free near the LDEF just prior to retrieval. (See fig. 21.) Another was found in the Space Shuttle bay after the LDEF removal. Other components appear to be secure.

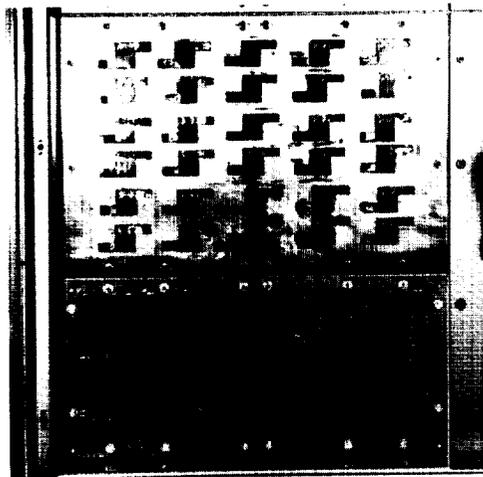
Figure 116
Photo No.: KSC-390C-1411.08
Dup. Neg. No.: L91-7689
LISAR No.: EL-1994-00338
Photo Credit: KSC
Photo Date: 3/1/9
Location: KSC SAEF II
Subject: Postflight Detail of Lower Left of Tray A8

Figure 116 (Postflight). This close-up photograph of Plate VI in the lower left one-sixth of the tray shows that the solar cell components appear to be without physical damage. The colors of the specimens seem to have darkened.

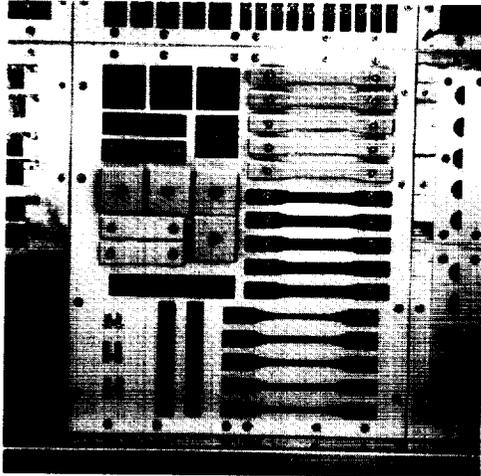
Figure 117
Photo No.: KSC-390C-1411.09
Dup. Neg. No.: L91-7690
LISAR No.: EL-1994-00361
Photo Credit: KSC
Photo Date: 3/1/90
Location: KSC SAEF II
Subject: Postflight Detail of Lower Center of
Tray A8

Figure 117 (Postflight). This close-up of Plate V in the lower center one-sixth of the tray shows that all specimens, including the tape holding down the small specimens in the lower left corner, have darkened significantly.

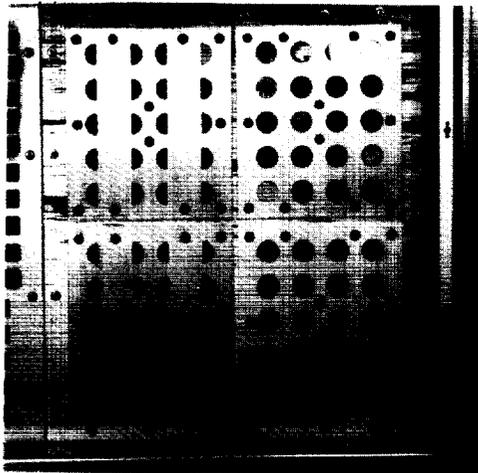
Figure 118
Photo No.: KSC-390C-1411.10
Dup. Neg. No.: L91-7691
LISAR No.: EL-1994-00362
Photo Credit: KSC
Photo Date: 3/1/90
Location: KSC SAEF II
Subject: Postflight Detail of Lower Right of
Tray A8

Figure 118 (Postflight). In this close-up of the lower right one-sixth of the tray, several of the coatings appear to have darkened and a unique pattern of light brown discoloration appears around the outer edges of the mounting plate and along the lower edge of the coverplates.

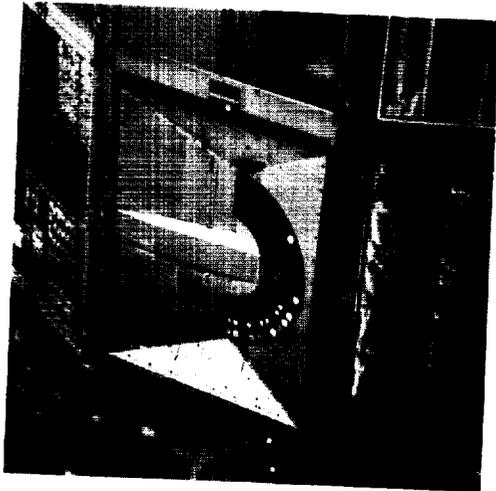
Figure 120
Photo No.: S32-76-005
Dup. Neg. No.: L90-10375
LISAR No.: EL-1994-00660
Photo Credit: JSC
Photo Date: 1/12/90
Location: In Flight
Subject: In-Flight Survey of Tray A9

Figure 120 (In Flight). Here, the original silver mirrorlike shroud surface appears white with copious amounts of a brown discoloration in a distinct pattern. The upper and lower triangular sections of the shroud have many irregular black discolorations and areas where the adhesive appears to have failed. Changes in color have occurred in both the active and the passive test samples. The three radiometers appear to have no physical damage.

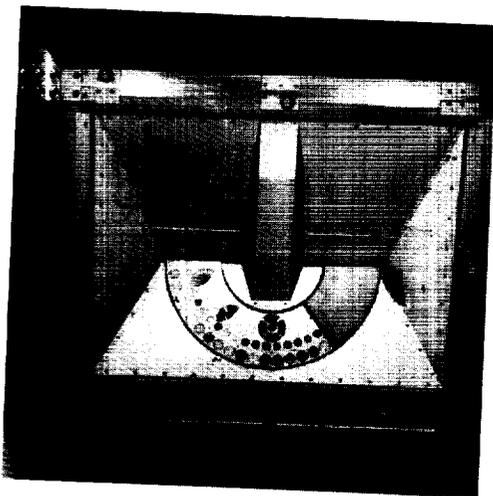
Figure 121
Photo No.: KSC-390C-1030.11
Dup. Neg. No.: L90-13409
LISAR No.: EL-1994-00144
Photo Credit: KSC
Photo Date: 2/9/90
Location: KSC SAEF II
Subject: Postflight Survey of Tray A9

Figure 121 (Postflight). The 2-mil silvered Teflon film surface on the shroud appears to be the same as in flight. It is white with brown discolorations in a distinct pattern. The left and right triangular sections of the shroud have many irregular black discolorations and areas where the adhesive appears to have failed.

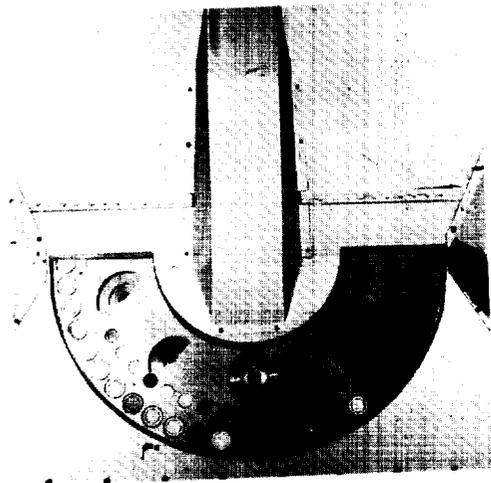
Figure 122
Photo No.: KSC-390C-1419.03
Dup. Neg. No.: L91-7715
LISAR No.: EL-1994-00375
Photo Credit: KSC
Photo Date: 2/28/90
Location: KSC SAEF II
Subject: Postflight Detail of Tray A9

Figure 122 (Postflight). This close-up photograph is of the carousel and test specimens. Note the discoloration streaks on the silvered Teflon film in the upper portions of the photograph and the evidence of numerous small impact discolorations. While changes in color have occurred in both the active and passive test samples, they appear to be the same as in flight. The three radiometers seem to be without physical damage.

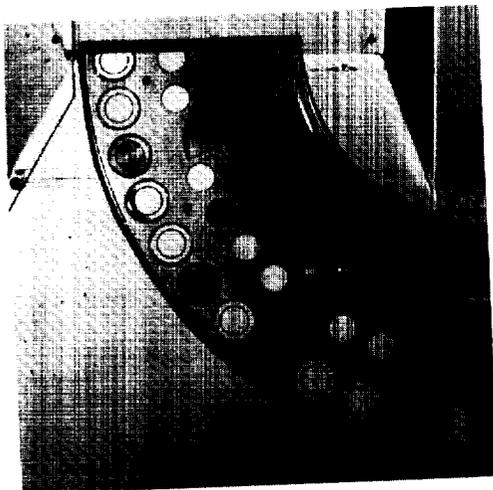
Figure 123
Photo No.: KSC-390C-1419.04
Dup. Neg. No.: L91-7716
LISAR No.: EL-1994-00376
Photo Credit: KSC
Photo Date: 2/28/90
Location: KSC SAEF II
Subject: Postflight Detail of Tray A9

Figure 123 (Postflight). This close-up photograph is of the left area of the exposed test samples. The calorimeter outer edge appears to be deformed in the fourth from top (outer) active sample location. The passive samples, located on the inner radius, seem to have no physical damage; however, some of the white paint samples now appear brown or tan. A point of space debris impact is located just off the edge of the carousel.

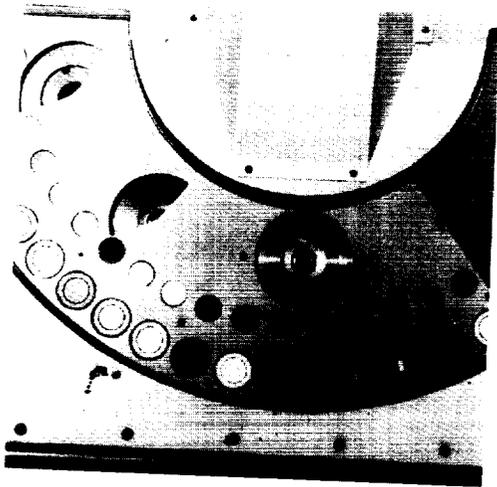
Figure 124
Photo No.: KSC-390C-1419.05
Dup. Neg. No.: L91-7717
LISAR No.: EL-1994-00377
Photo Credit: KSC
Photo Date: 2/28/90
Location: KSC SAEF II
Subject: Postflight Detail of Tray A9

Figure 124 (Postflight). This close-up is of the center area of the exposed test specimens. Some of the test specimens appear discolored and damaged. Note the first four from the right active coating samples, which are located on the outer radius. Two of the first three, which were originally white, now appear brown and have significant damage. The fourth active sample from the right, which was originally black, appears to have eroded, thus leaving only a trace of the paint or primer on the substrate. The passive samples, located on the inner radius, appear to have no physical damage; however, some of the white paint samples now appear brown or tan.

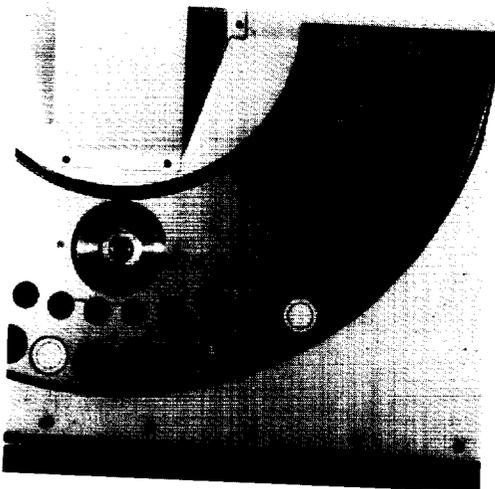
Figure 125
Photo No.: KSC-390C-1419.06
Dup. Neg. No.: L91-7718
LISAR No.: EL-1994-00378
Photo Credit: KSC
Photo Date: 2/28/90
Location: KSC SAEF II
Subject: Postflight Detail of Tray A9

Figure 125 (Postflight). This close-up photograph is of the right area of the exposed test specimens. Some of the test specimens are discolored and damaged. Note the first four from the right active coating samples located on the outer radius. Two of the first three, which were originally white, now appear brown and have significant damage. The fourth active sample from the right, which was originally black, appears to have eroded, thus leaving only a trace of the paint or primer on the substrate. The passive samples, located on the inner radius, appear to have no physical damage; however, some of the white paint samples now appear brown or tan.

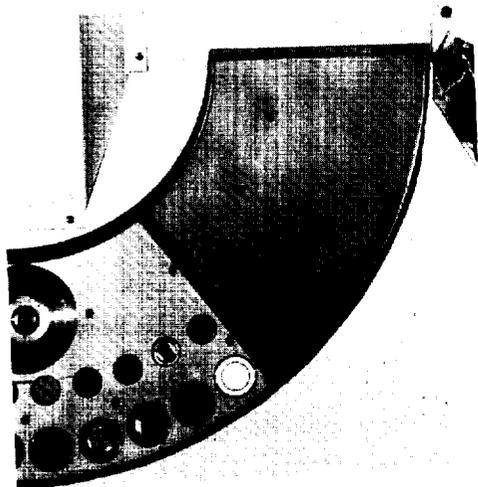
Figure 126
Photo No.: KSC-390C-1419.07
Dup. Neg. No.: L91-7719
LISAR No.: EL-1994-00379
Photo Credit: KSC
Photo Date: 2/28/90
Location: KSC SAEF II
Subject: Postflight Detail of Tray A9

Figure 126 (Postflight). This close-up of the right area of the carousel and tray bottom shows the area of damaged silvered Teflon film. Numerous discolorations from space debris impacts are also visible.

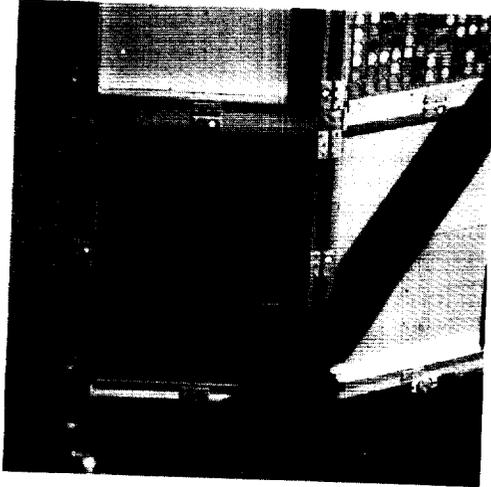
Figure 137
Photo No.: S32-78-058
Dup. Neg. No.: L90-10438
LISAR No.: EL-1994-00013
Photo Credit: JSC
Photo Date: 1/12/90
Location: In Flight
Subject: In-Flight Survey of Tray A11

Figure 137 (In Flight). The experiment appears to be intact. Impact craters, which appear as small white imperfections in the dark blue background, are visible on all six detector plates. The apparent dark blue of the aluminum detector panels in this photograph is the result of the lighting and the camera angle.

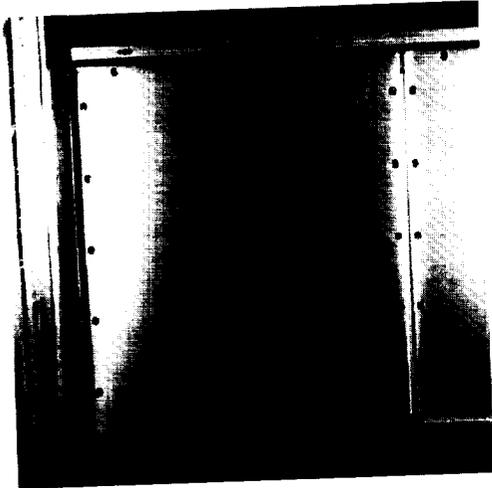
Figure 139
Photo No.: KSC-390C-1697.11
Dup. Neg. No.: L91-7806
LISAR No.: EL-1994-00228
Photo Credit: KSC
Photo Date: 3/7/90
Location: KSC SAEF II
Subject: Postflight Detail of Upper Left Plate of
Tray A11

Figure 139 (Postflight). This close-up photograph is of the upper left plate. The very small white dots are impact craters. The lighter area to the left is a result of photographic light reflections.

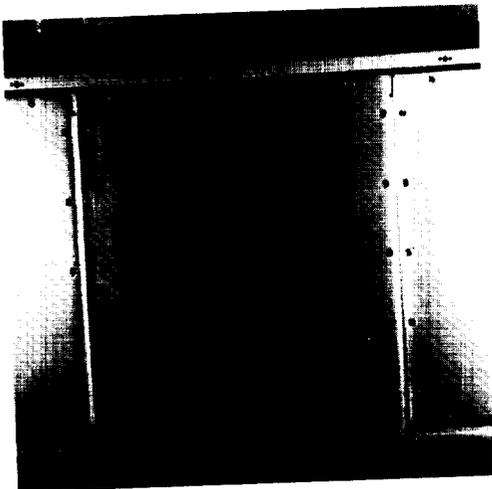
Figure 140
Photo No.: KSC-390C-1697.12
Dup. Neg. No.: L91-7807
LISAR No.: EL-1994-00229
Photo Credit: KSC
Photo Date: 3/7/90
Location: KSC SAEF II
Subject: Postflight Detail of Upper Center Plate of
Tray A11

Figure 140 (Postflight). This close-up photograph is of the upper center plate. The very small white dots are impact craters.

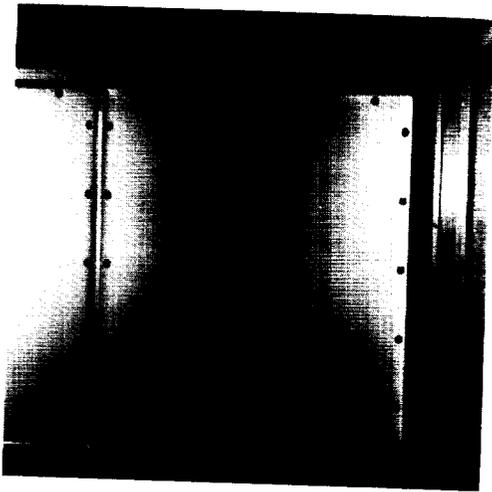
Figure 141
Photo No.: KSC-390C-1699.02
Dup. Neg. No.: L91-7815
LISAR No.: EL-1994-00230
Photo Credit: KSC
Photo Date: 3/7/90
Location: KSC SAEF II
Subject: Postflight Detail of Upper Right Plate of
Tray A11

Figure 141 (Postflight). This close-up photograph is of the upper right plate. The very small white dots are impact craters.

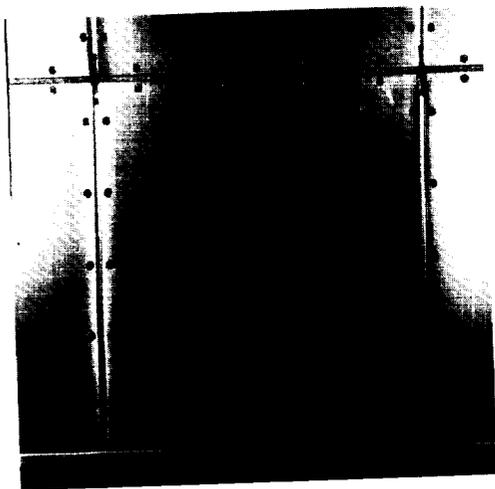
Figure 143
Photo No.: KSC-390C-1699.04
Dup. Neg. No.: L91-7817
LISAR No.: EL-1994-00232
Photo Credit: KSC
Photo Date: 3/7/90
Location: KSC SAEF II
Subject: Postflight Detail of Lower Center Plate of
Tray A11

Figure 143 (Postflight). This close-up photograph is of the lower center plate. The very small white dots are impact craters.

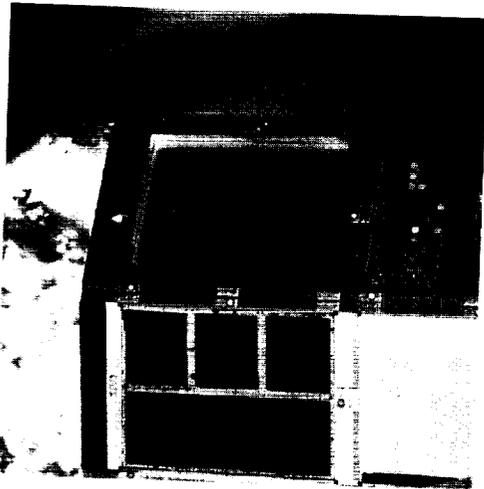
Figure 145
Photo No.: S32-78-029
Dup. Neg. No.: L90-10430
LISAR No.: EL-1994-00006
Photo Credit: JSC
Photo Date: 1/12/90
Location: In Flight
Subject: In-Flight Survey of Tray A12

Figure 145 (In Flight). The greenish-gray tint on the two debris panels is the by-product of the chromic anodization coating process. The blue tint can be attributed to reflections of the sky. The vertical streaks on the debris panels are by-products of chromic anodizing; these streaks have been enhanced by the blue reflection. Brown stains are located along the left edge of the right debris panel. An irregular discoloration extends horizontally across the lower half of the left debris panel. The light band along the vertical edge of the left debris panel and across the top of both debris panels is a reflection from the tray sidewall.

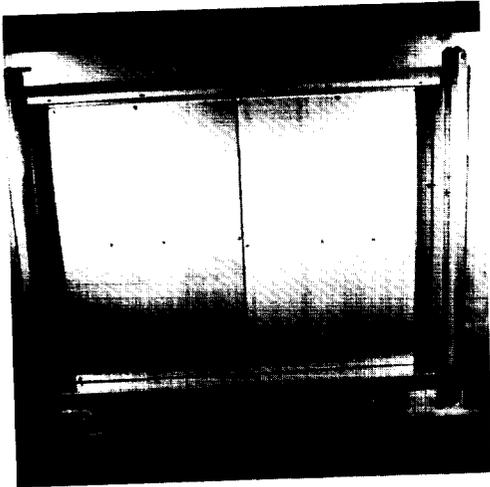
Figure 146
Photo No.: KSC-390C-2163.03
Dup. Neg.: L91-7828
LISAR No.: EL-1994-00472
Photo Credit: KSC
Photo Date: 3/21/90
Location: KSC SAEF II
Subject: Postflight Survey of Tray A12

Figure 146 (Postflight). The pink and greenish-gray tints on the two debris panels are by-products of the chromic anodization coating process and are not attributed to contamination or exposure to the space environment. The vertical streaks observed on the right debris panel in the in-flight photograph are still visible, although they are not as distinct. The irregular discoloration extending horizontally across the left debris panel remains well defined. The light band across the top and bottom of the debris panels is caused by light reflecting from the tray sidewalls.
